QUANTIFICATION OF QUALITATIVE DEFECTS FOR AUTOMOBILE CUSTOMERS

**Bachelor of Technology
Metallurgical and Materials Engineering Department**

NATIONAL INSTITUTE OF TECHNOLOGY, ROURKELA

May, 2014

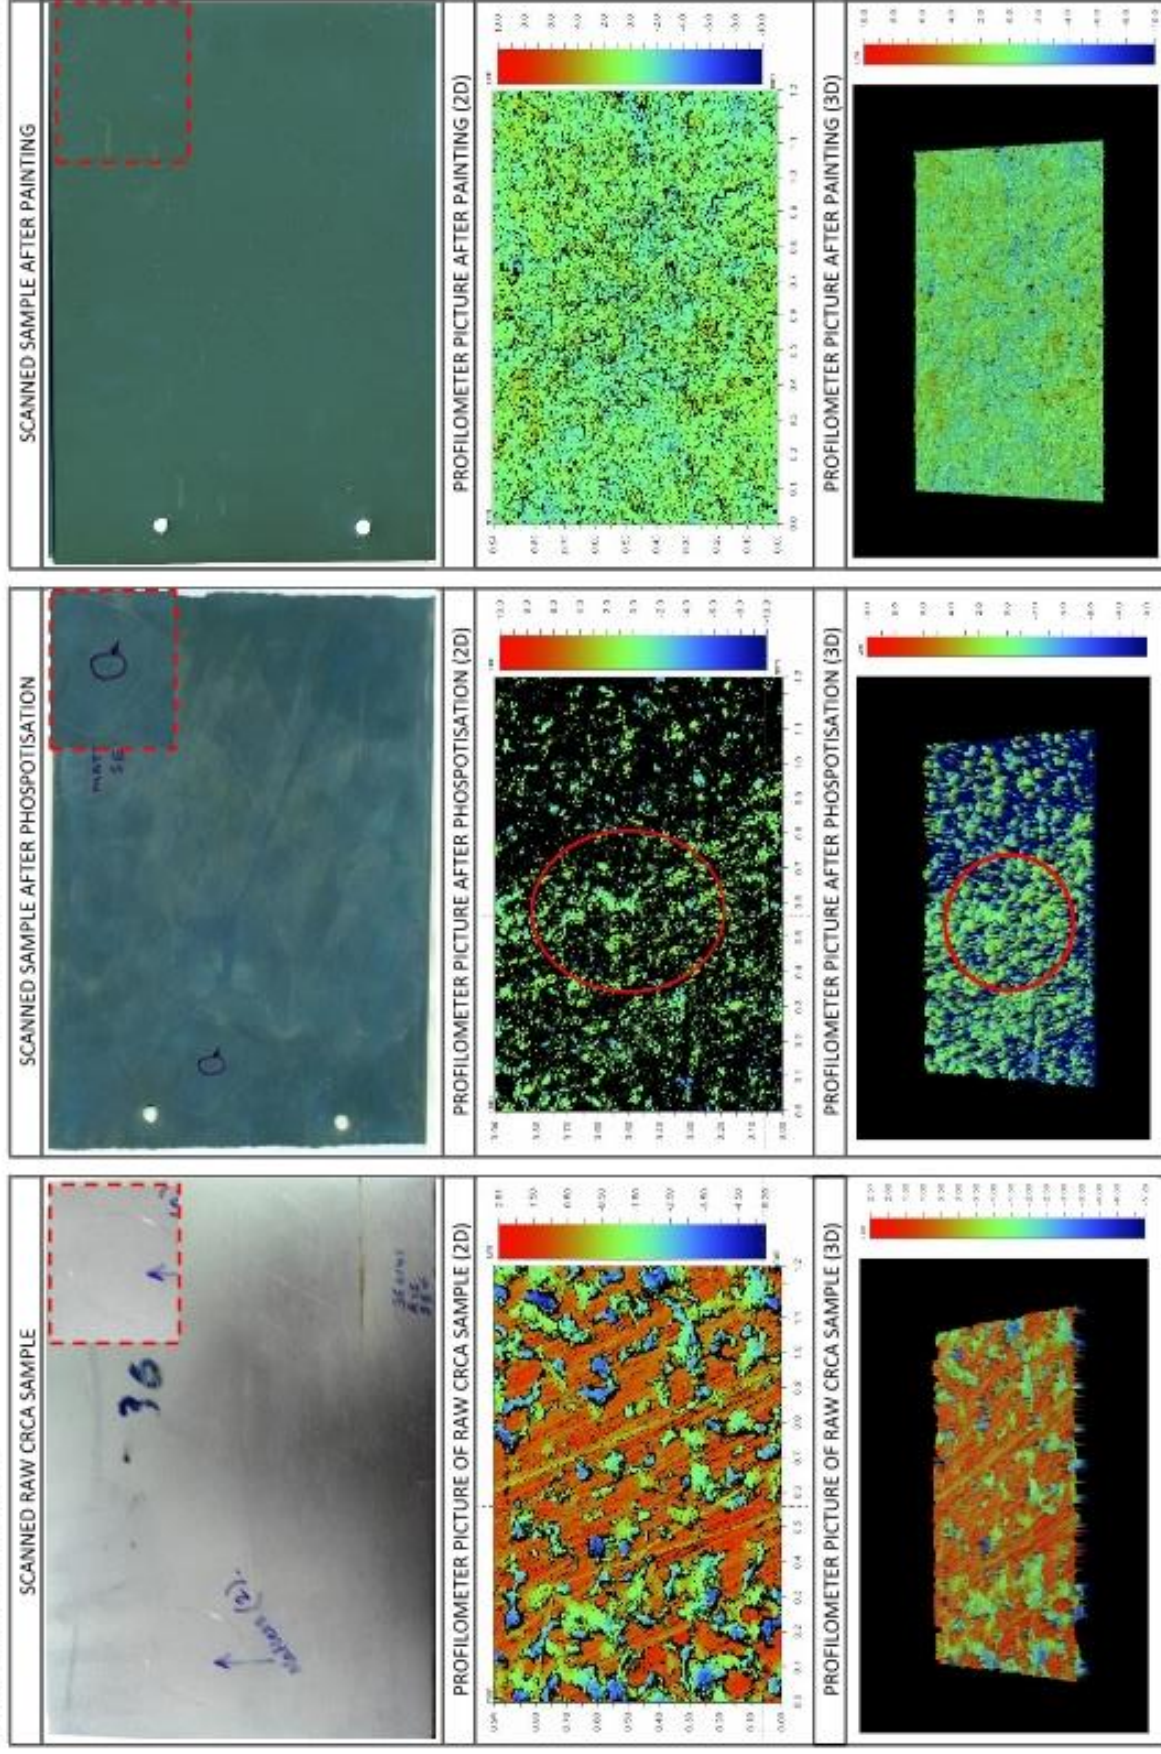
Fig: 5.1.1

COIL ID: 3601411000

DEFECT: MATTLESS SPOT

SEVERITY: 2

1. Mattless Spot up to 5 Severity range can be passed. The difference in total roughness obtained between defected and non-defected area after 1st layer of painting was the order of 0.2 – 0.5 μm .

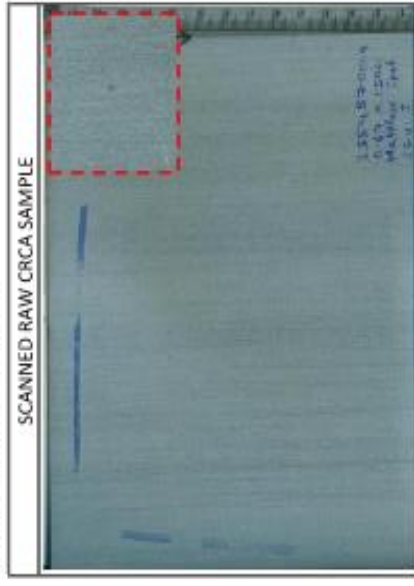
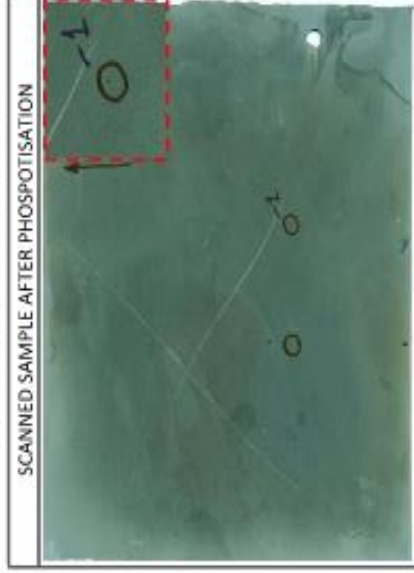
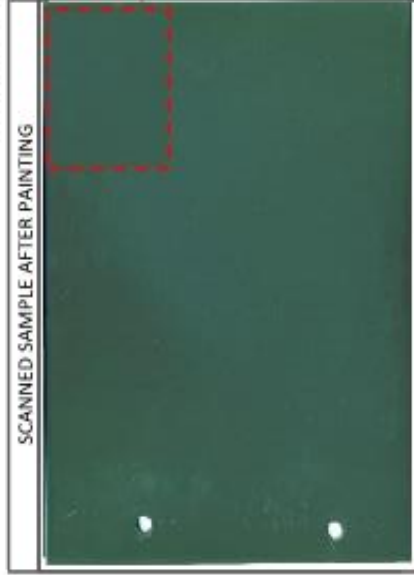
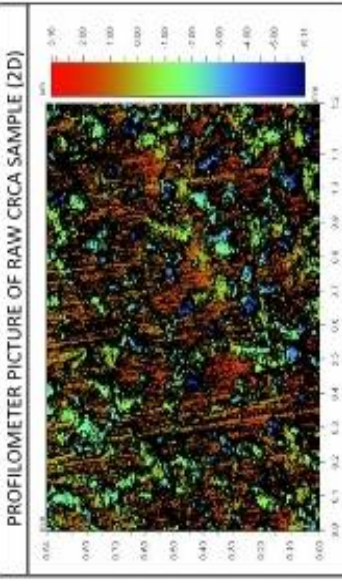
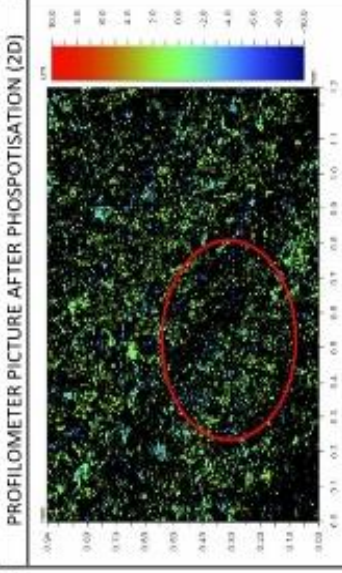
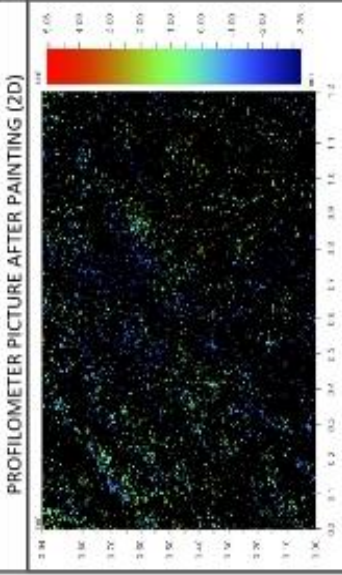
Fig: 5.1.3

COIL ID: 3554571000

DEFECT: MATTLESS SPOT

SEVERITY: 3

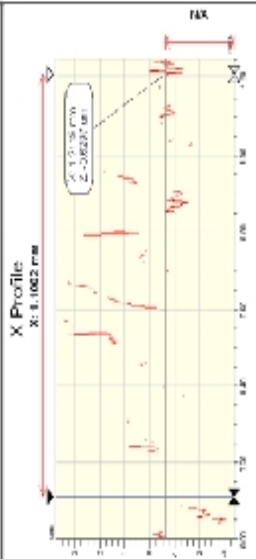
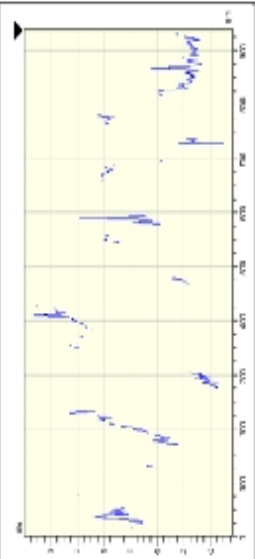
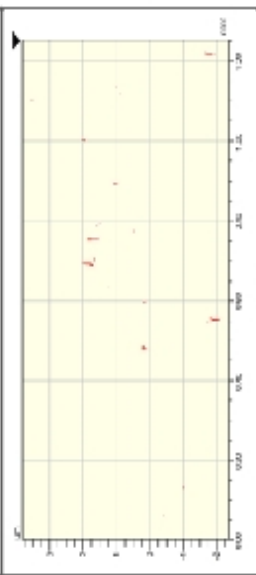
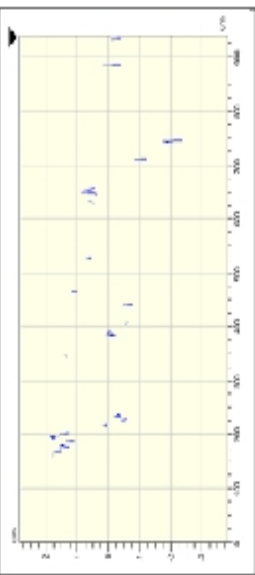
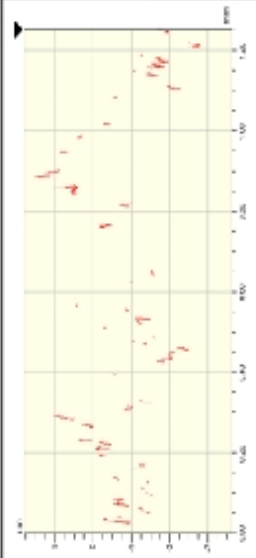
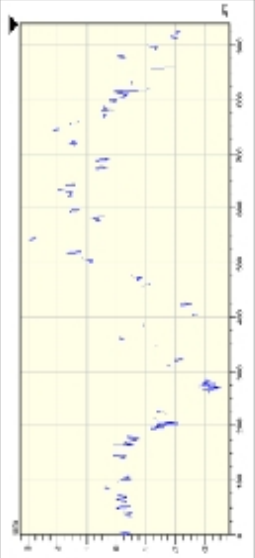
COIL ID: 2612021000		DEFECT: ROLL MARK		SEVERITY: 4	
RAW CRCA SAMPLE

THICKNESS: 2.30 mm		YIELD STRENGTH (YS): 137 Pa		ULTIMATE TENSILE STRENGTH: 275 Pa	
PHOSPATING THICKNESS: 1-2 um, DRY FILM THICKNESS: 30 um for SPRAY PAINTING					
CONCLUSION					
DEPTH BEFORE PHOSPHOTISATION	5.21 um	DEPTH AFTER PHOSPHOTISATION	5.61 um	DEPTH AFTER PAINTING	4.92 um

<p>Roll Mark/Dent of Severity 4 is NOT OK for skin panel application. The 'depth of the defect after painting' and 'normal profile of the painted non-defected area' is incomparable suggesting it has not covered the defect.</p> <p>The Roughness of the unaffected area of the sample after painting is 3.64 um, showing the values are incomparable to the roughness of defect after painting.</p>

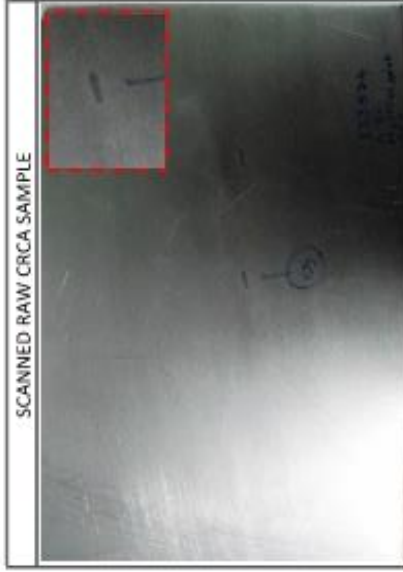
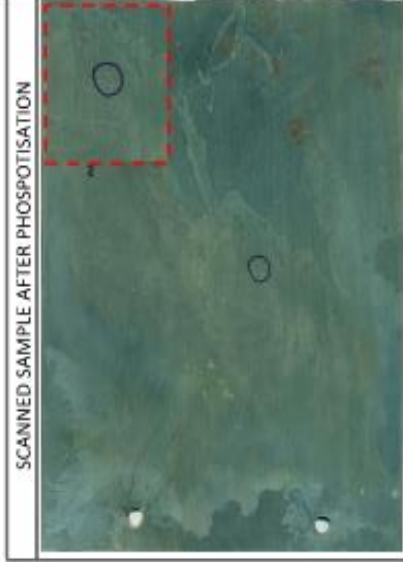
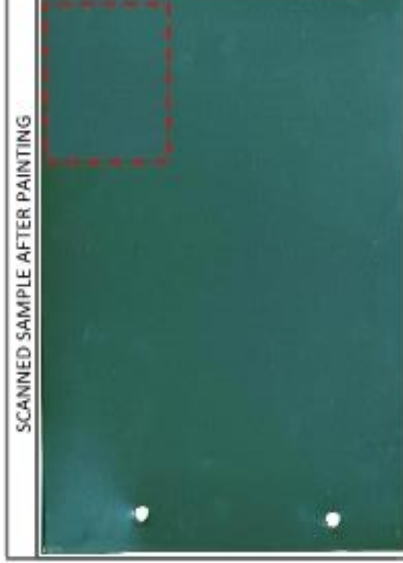
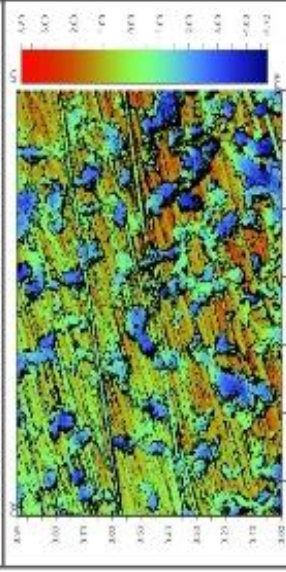
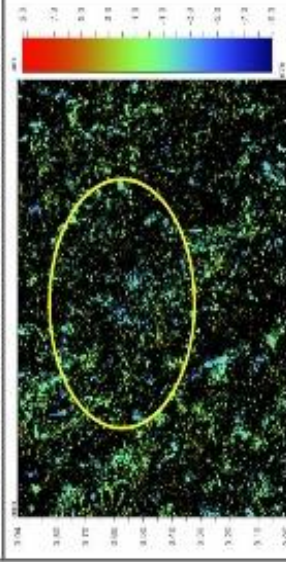
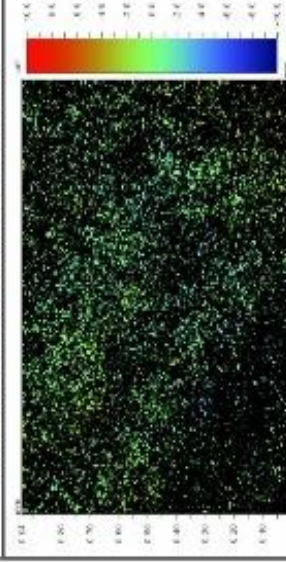
Fig: 5.1.7

COIL ID: 3335741000

DEFECT: MATTLESS SPOT

SEVERITY: 5

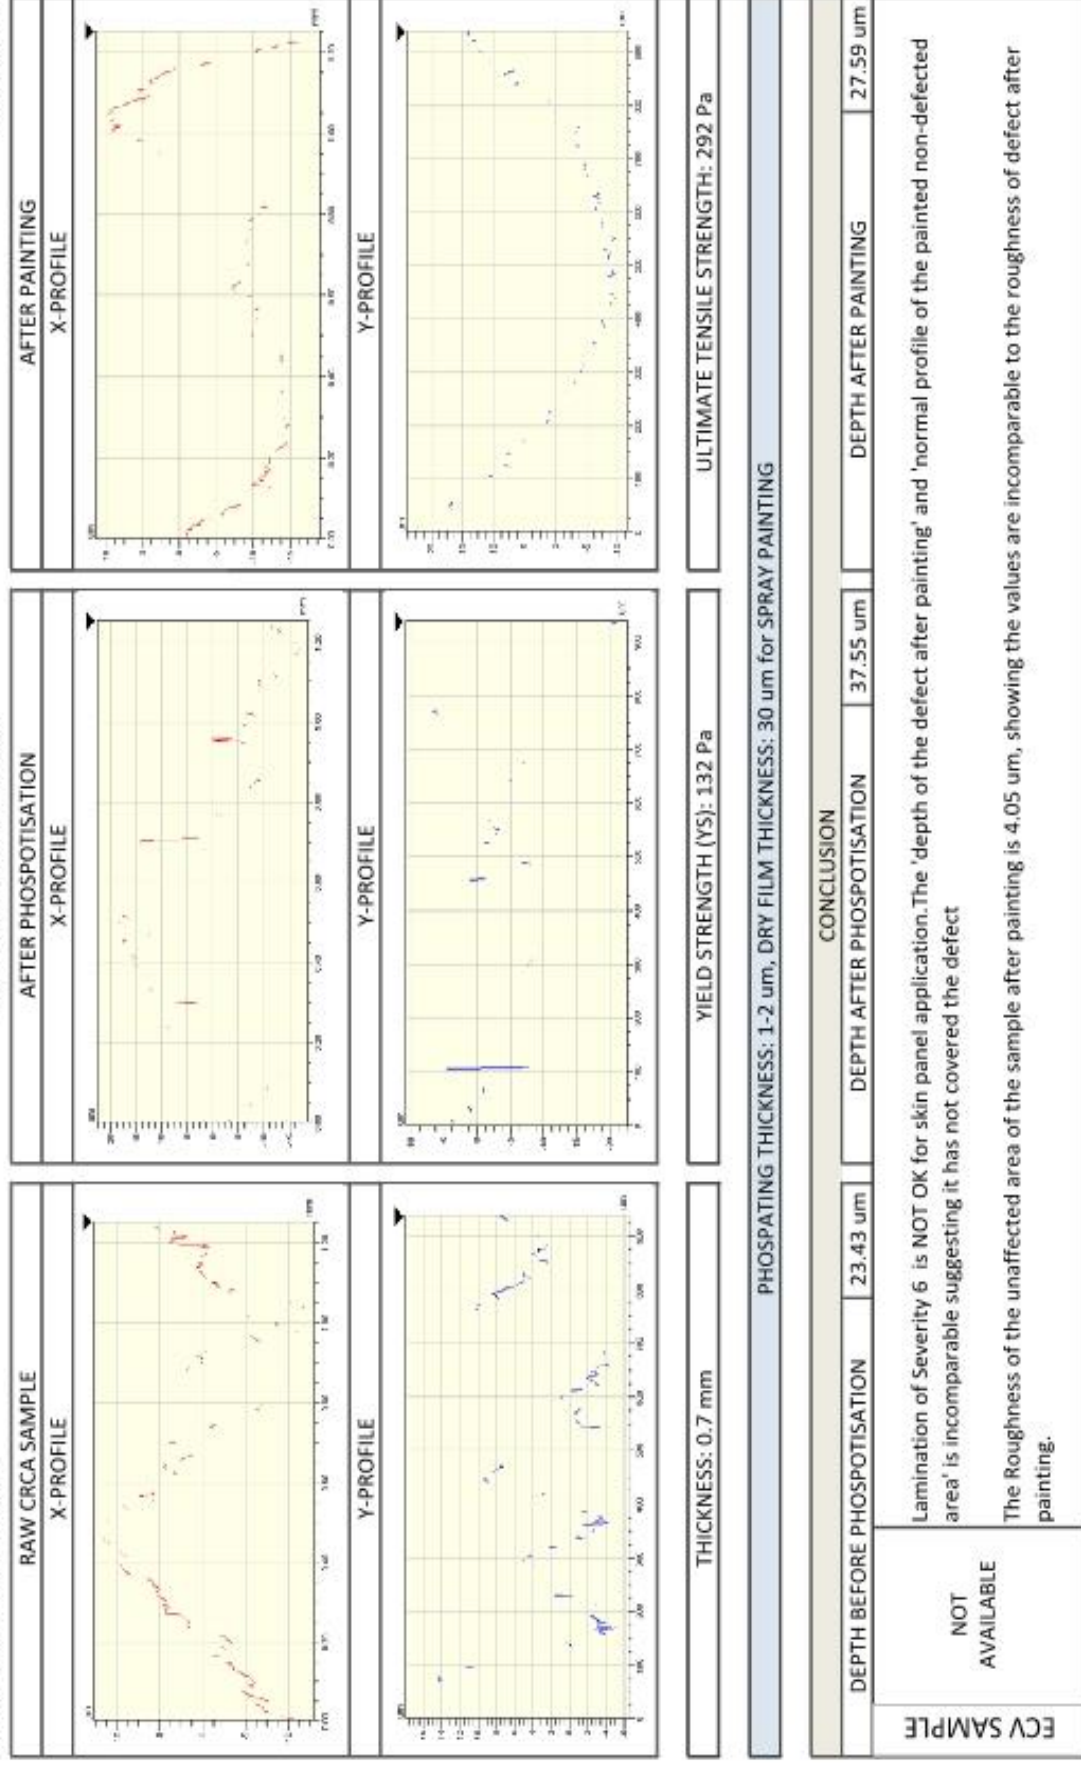
Fig: 5.2.4

COIL ID: 2865671000

DEFECT: LAMINATION

SEVERITY: 6

2. Lamination with the severity range of 4-7 cannot be passed. The difference in total roughness obtained between defected and non-defected area after 1st layer of painting was the order of 5 - 40 μm .

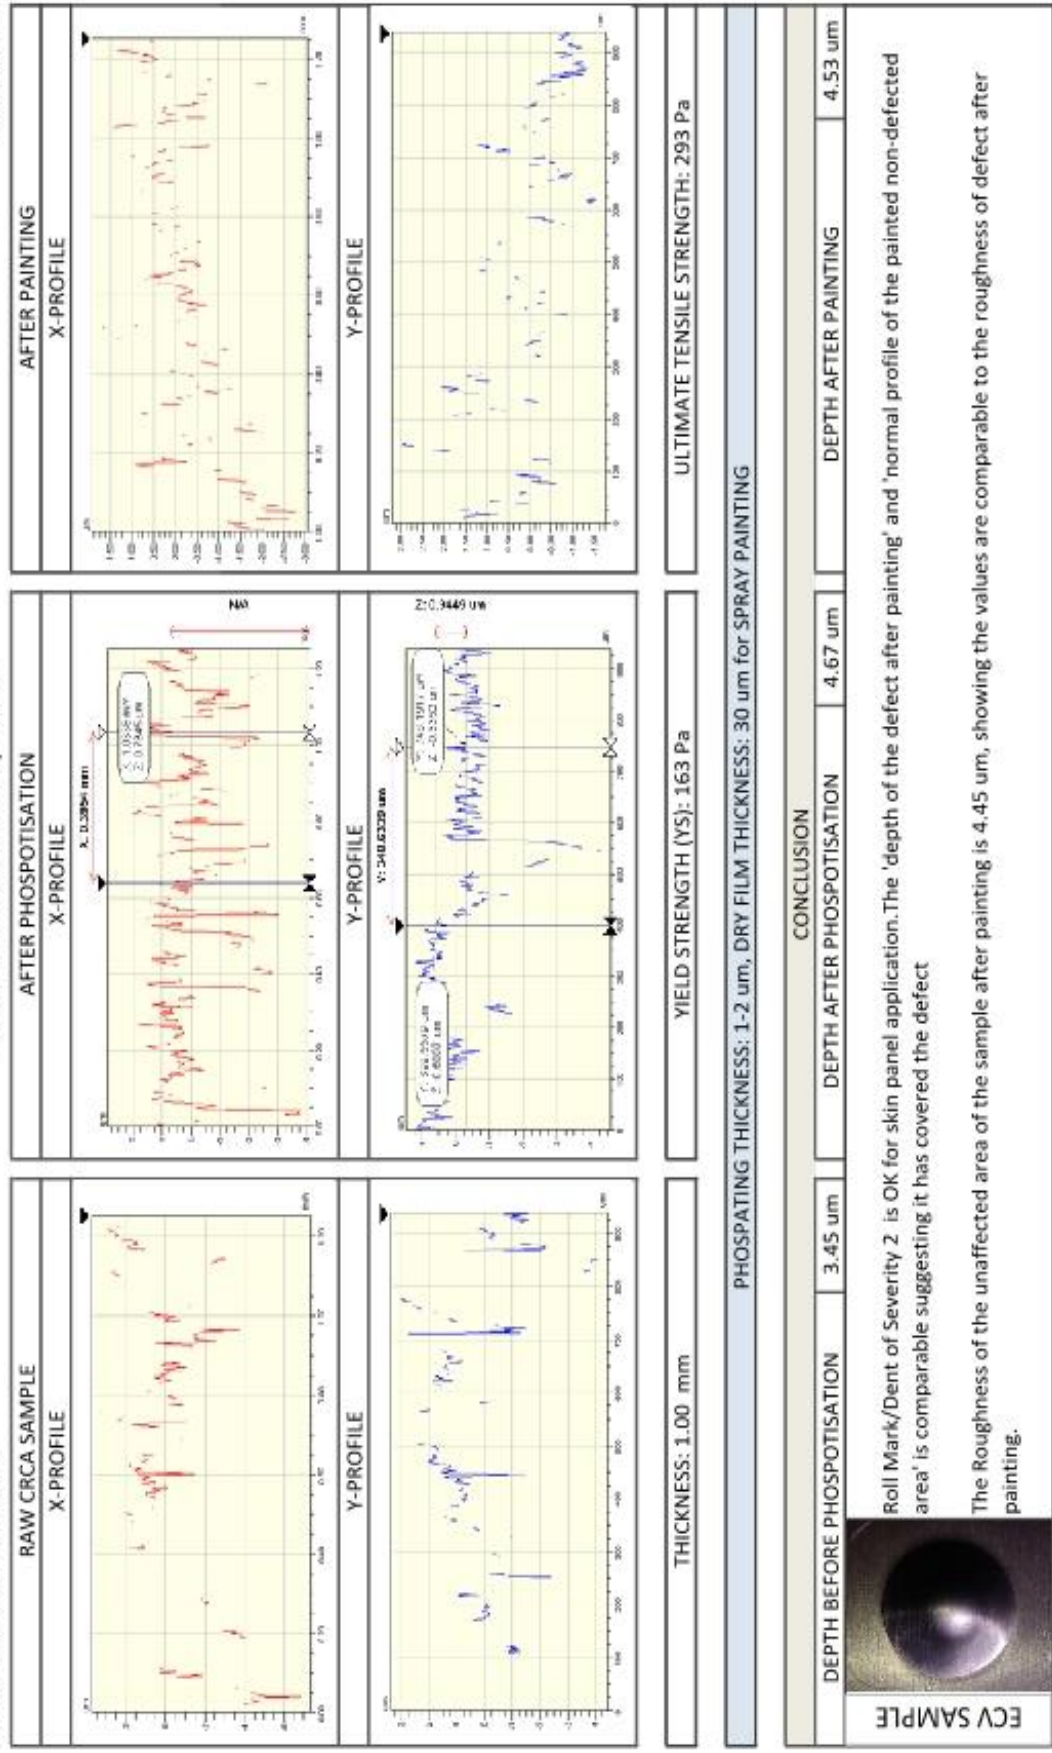
Fig: 5.3.2

SEVERITY: 2

DEFECT: ROLL MARK/DENT

COIL ID: 3457971000

3. Roll Mark/Dent up to 3 Severity can be passed. The difference in total roughness obtained between defected and non-defected area after 1st layer of painting was the order of 0.25 – 1.5 μm .

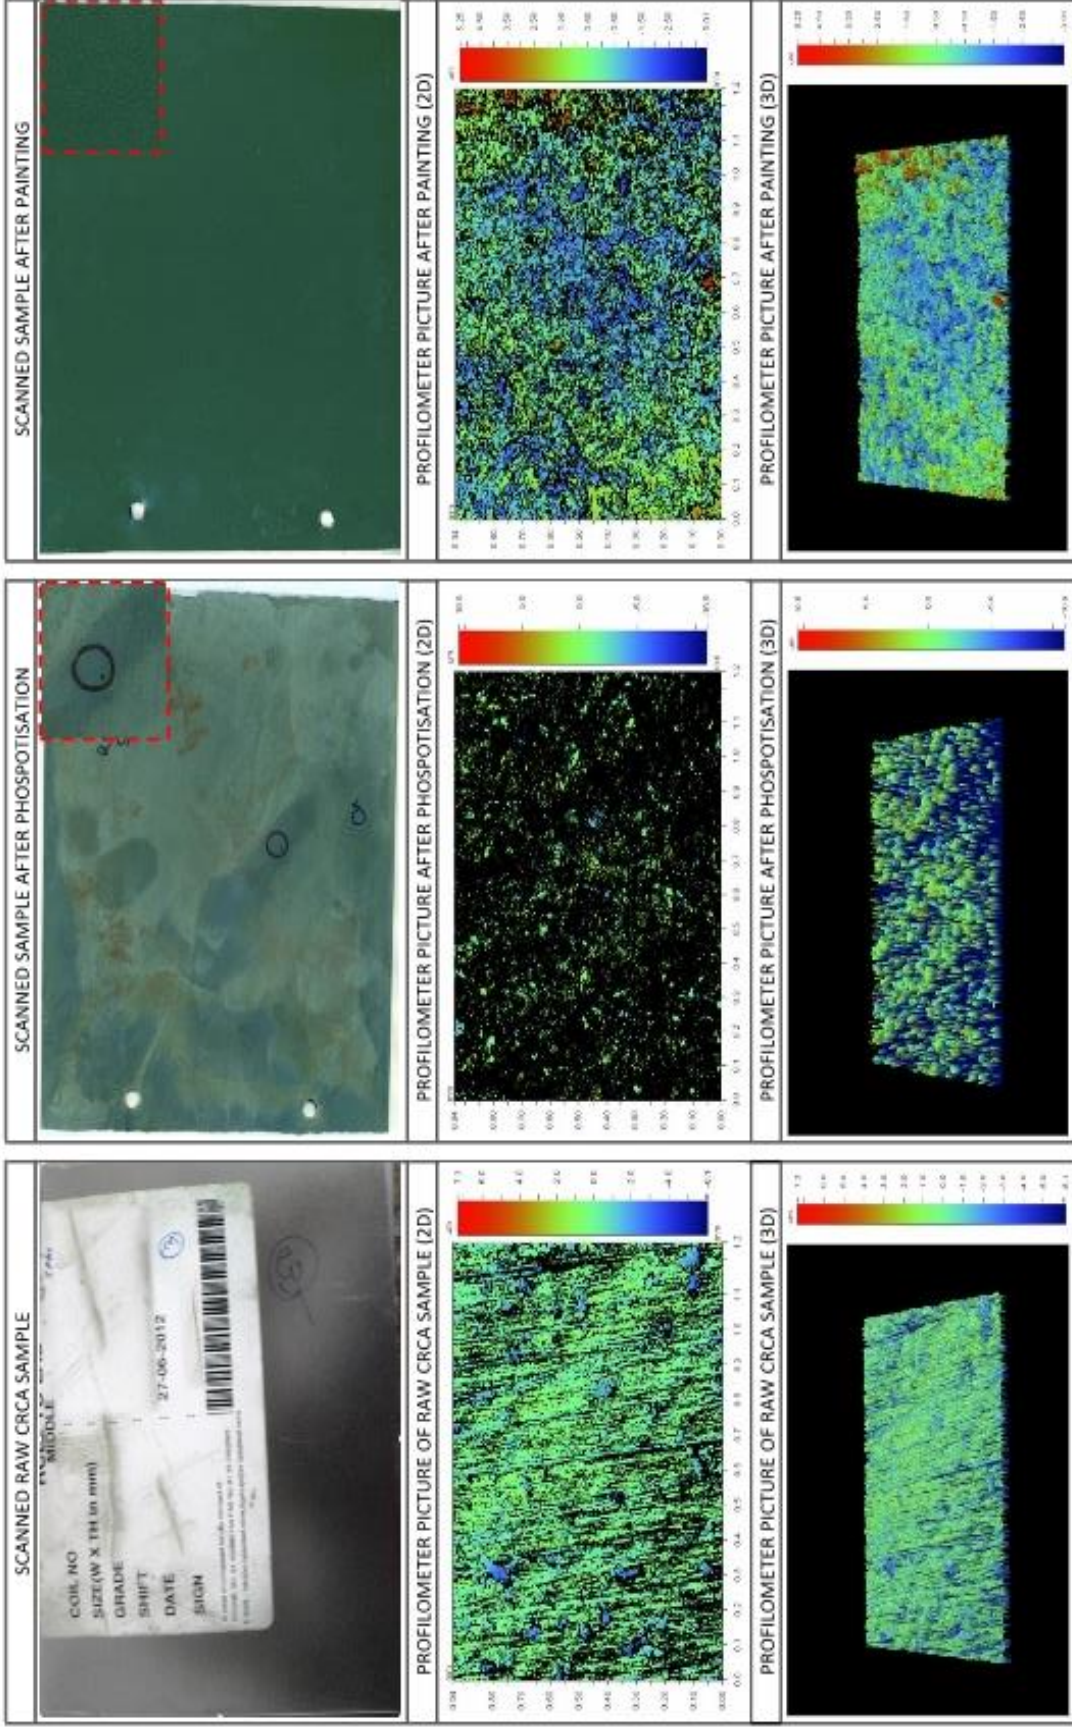
Fig: 5.3.3

COIL ID: 3735971000

DEPECT: ROLL MARK/DENT

SEVERITY: 3

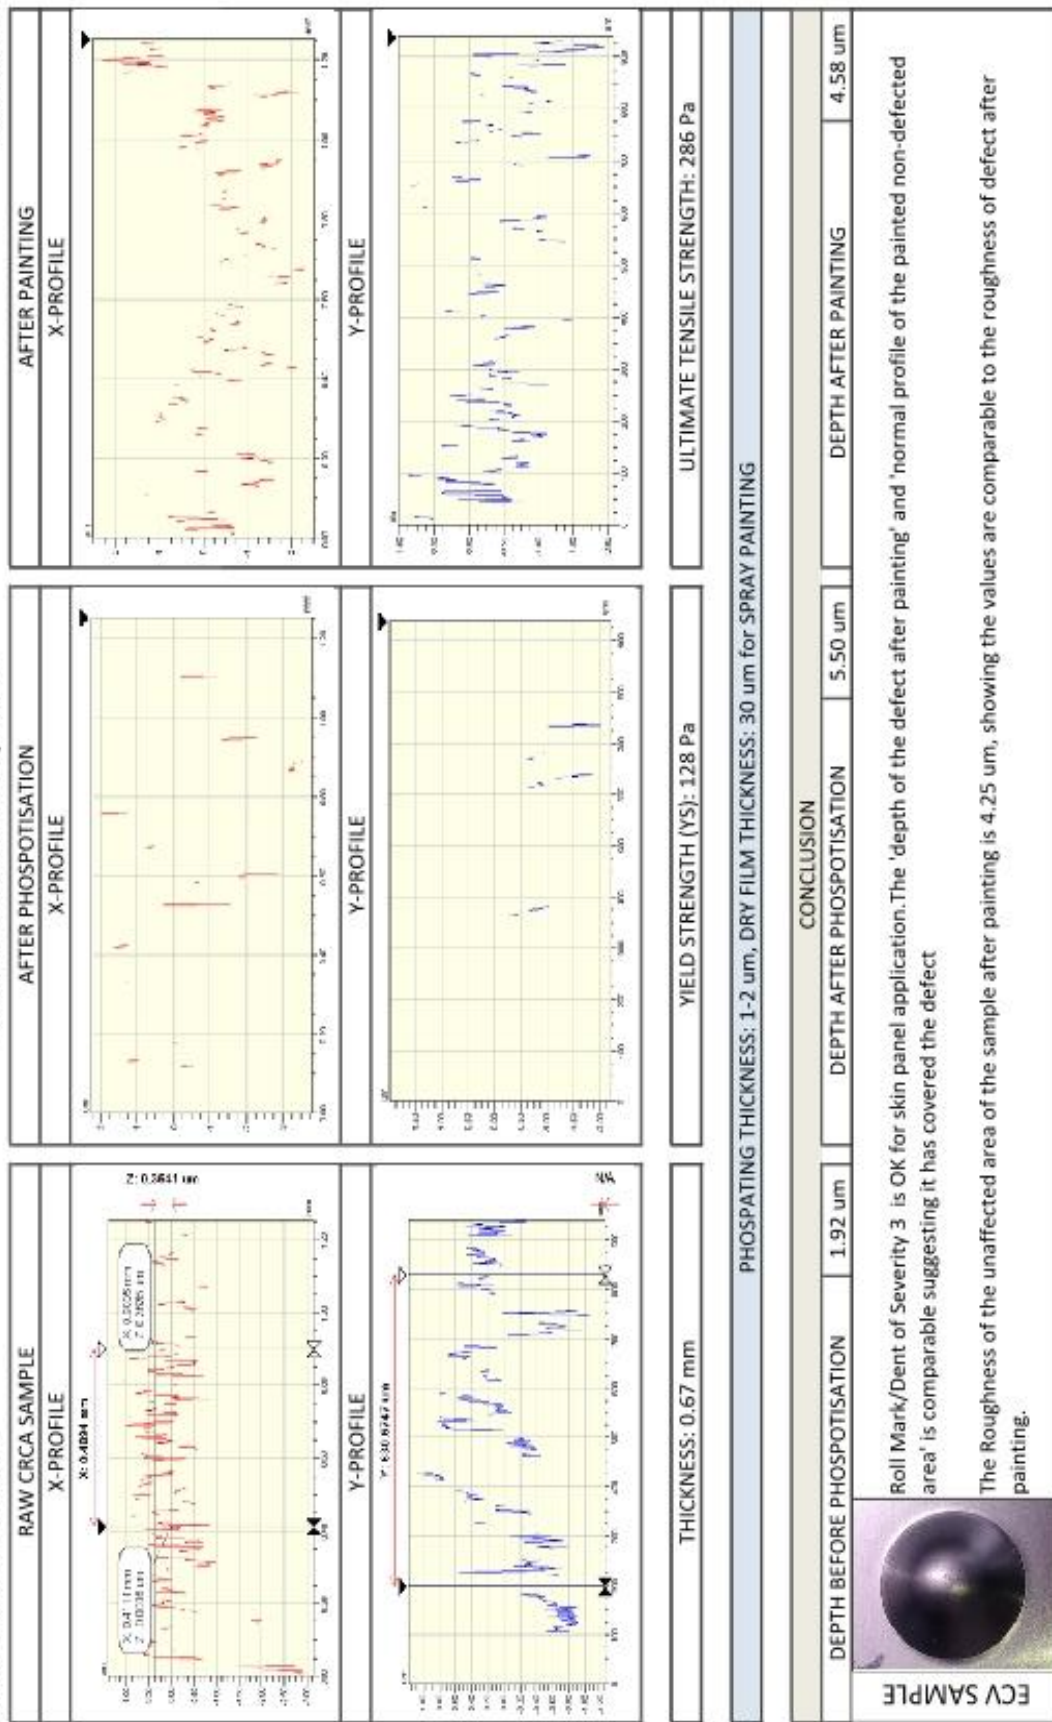
Fig: 5.3.4

COIL ID: 3735971000

DEFECT: ROLL MARK/DENT

SEVERITY: 3

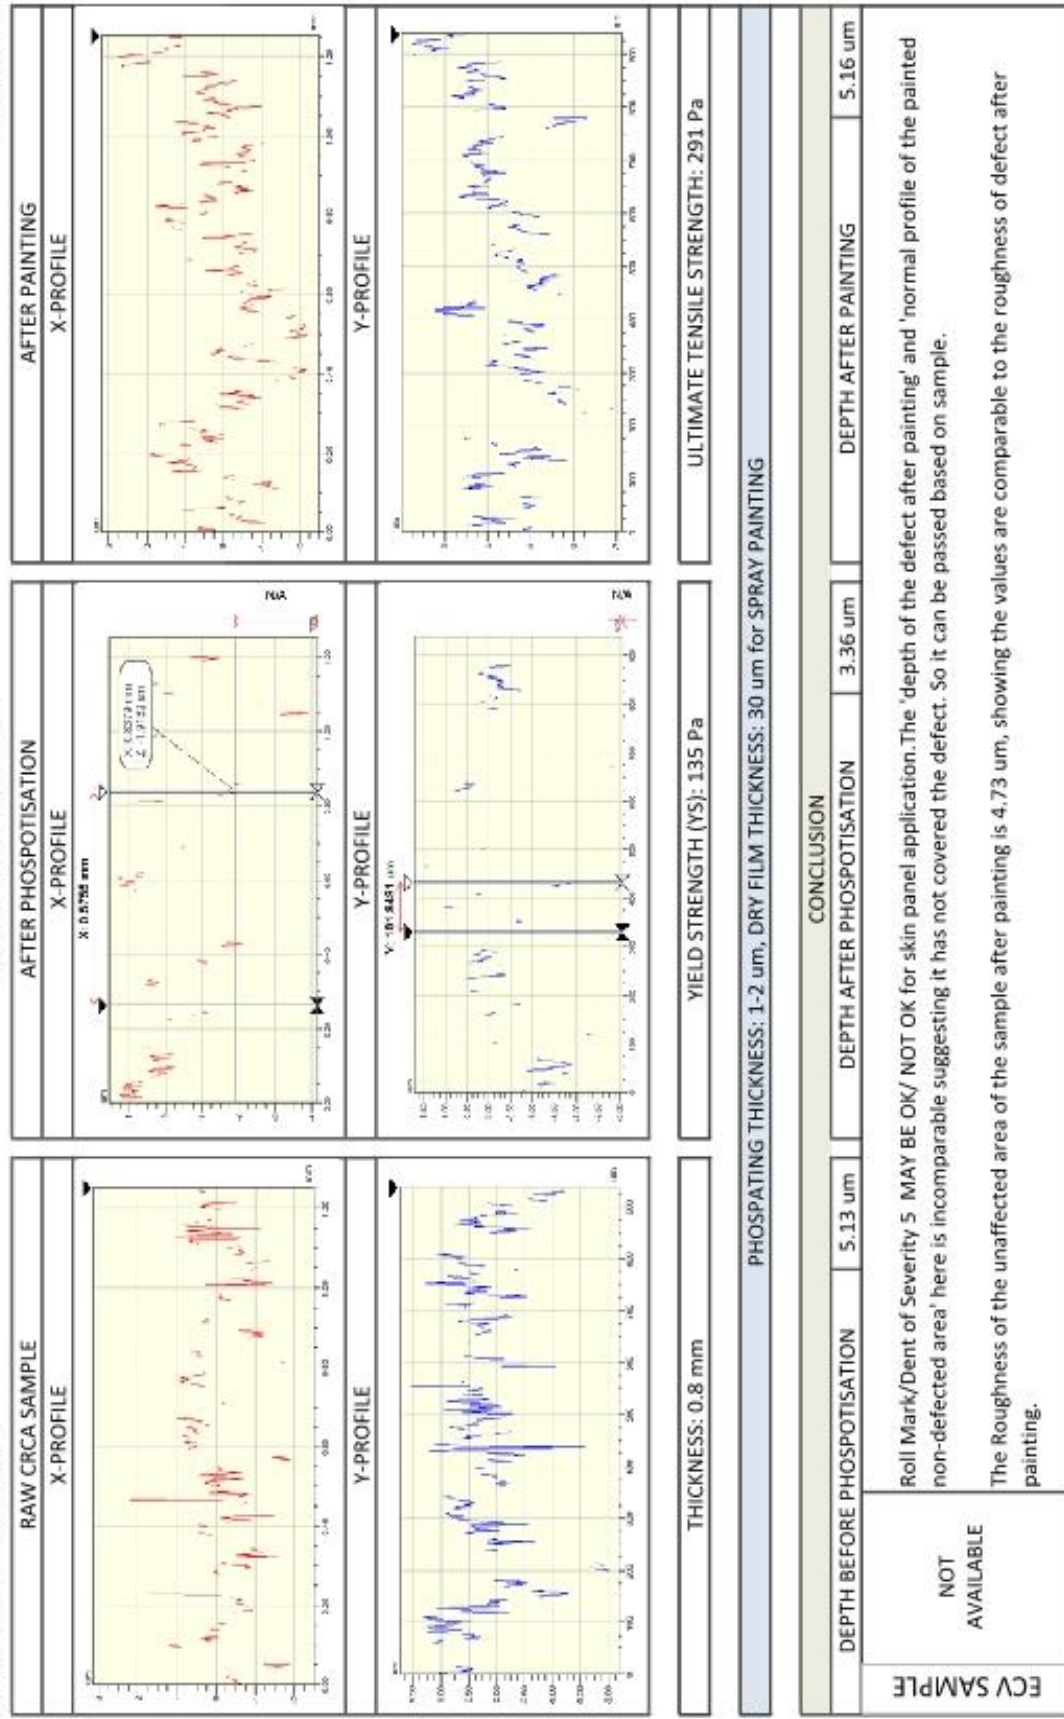
Fig: 5.3.8

SEVERITY: 5

DEFECT: ROLL MARK

COIL ID: 2760151000

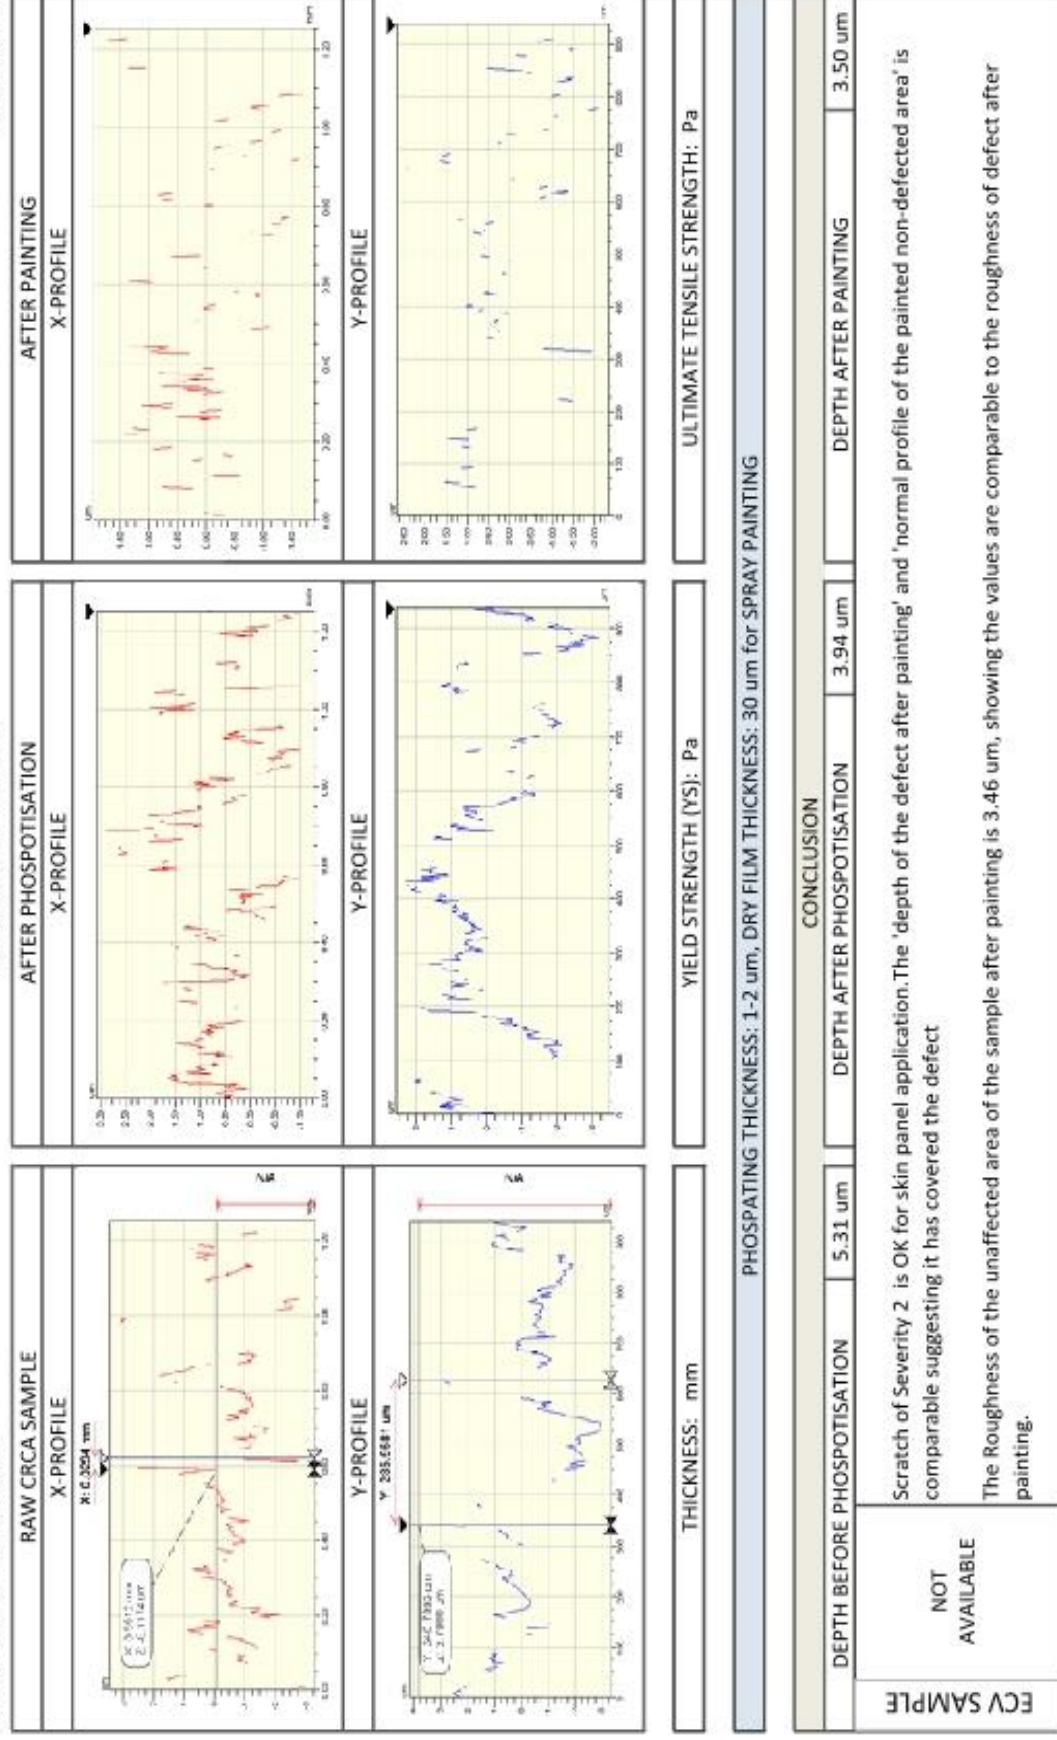
Fig: 5.4.2

COIL ID: 3519581000

DEFECT: SCRATCH

SEVERITY: 2

4. Scratch up to 4 Severity can be passed. The difference in total roughness obtained between defected and non-defected area after 1st layer of painting was the order of 0.2 – 0.4 μm .

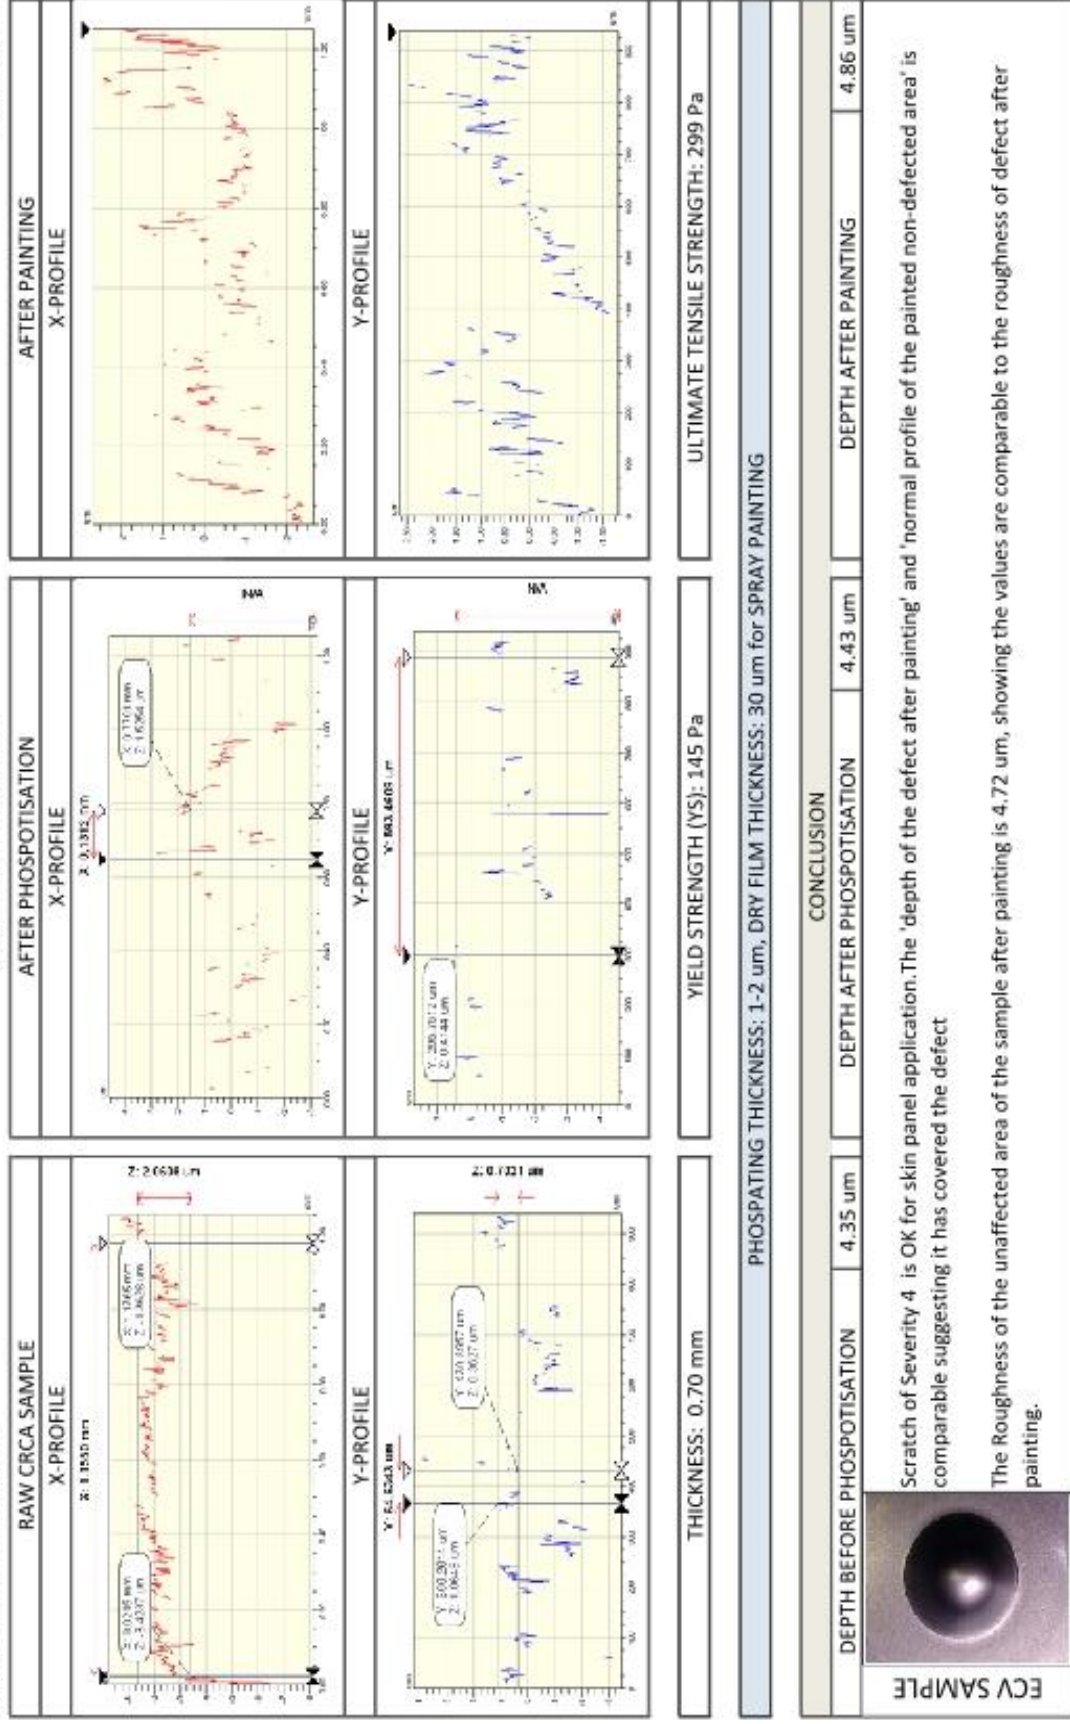
Fig: 5.4.6

COIL ID: 2757851000

DEFECT: SCRATCH

SEVERITY: 4

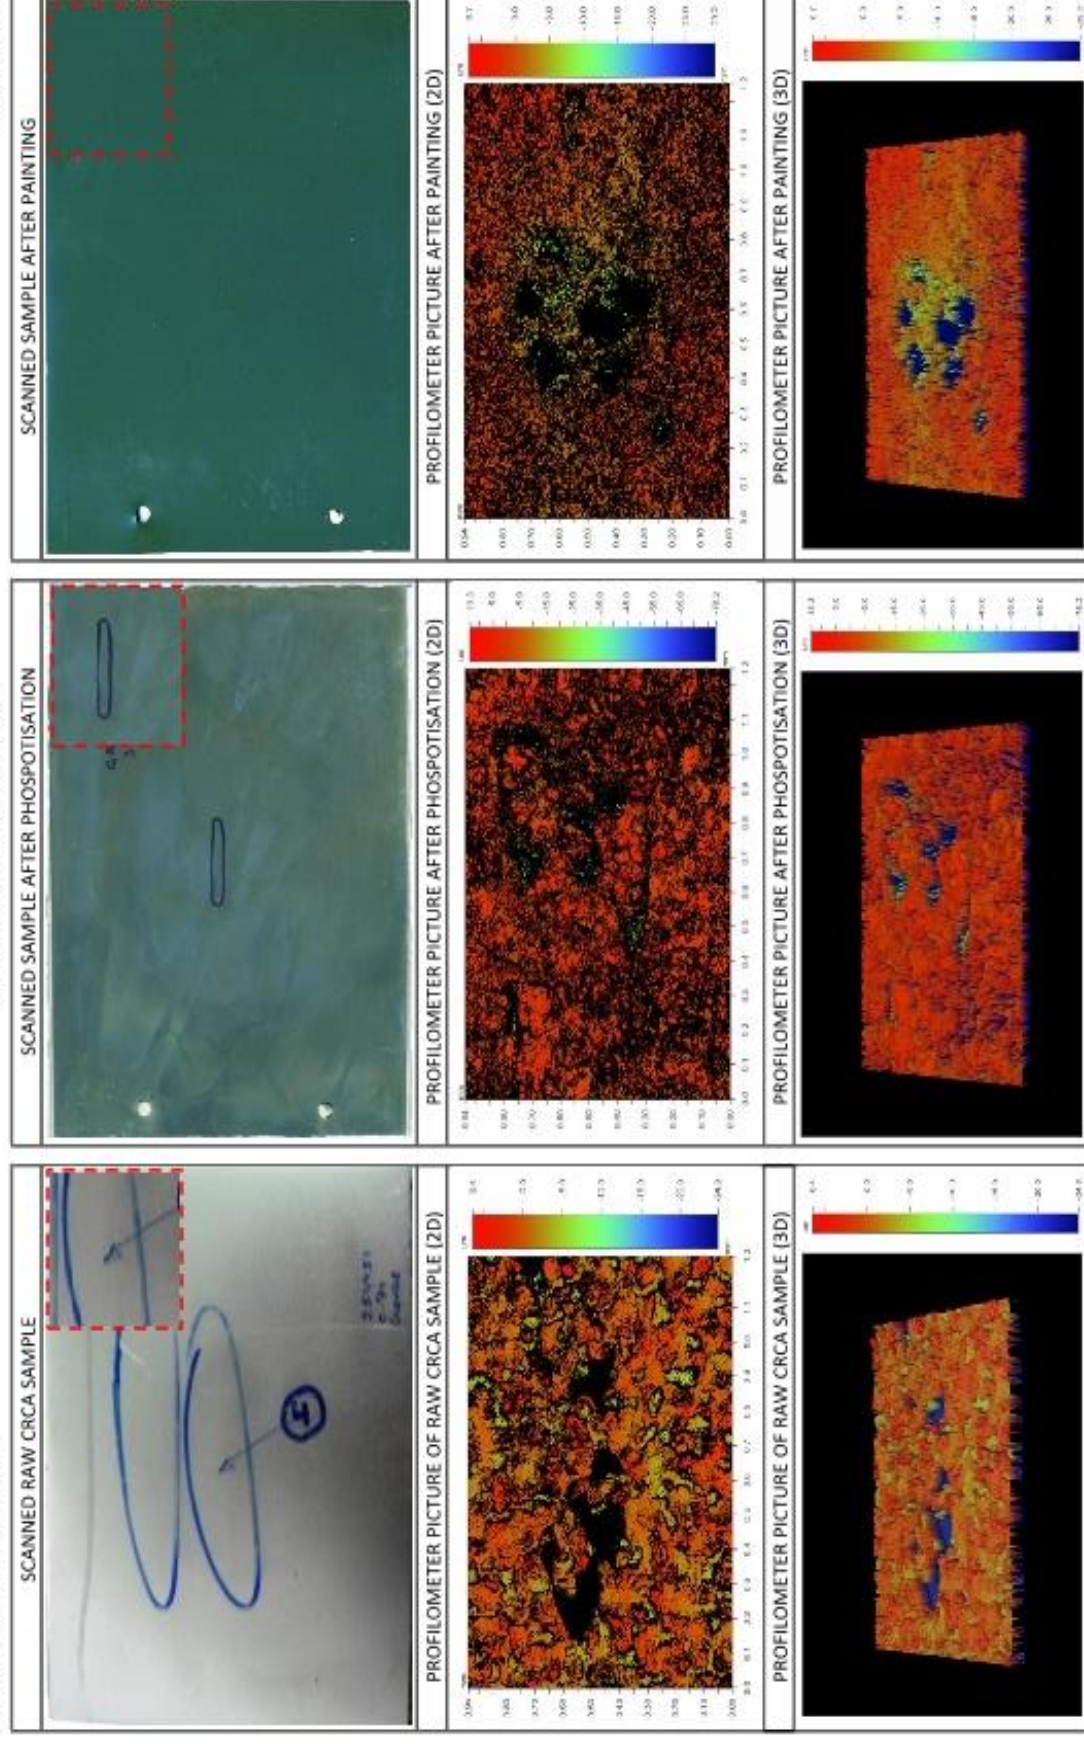
Fig: 5.5.1

COIL ID: 2544511000

DEFECT: GAUGE MARK

SEVERITY: 4

5. Gouge Mark from Severity 4-7 cannot be passed. The difference in total roughness obtained between defected and non-defected area after 1st layer of painting was the order of 8 – 10 μm .

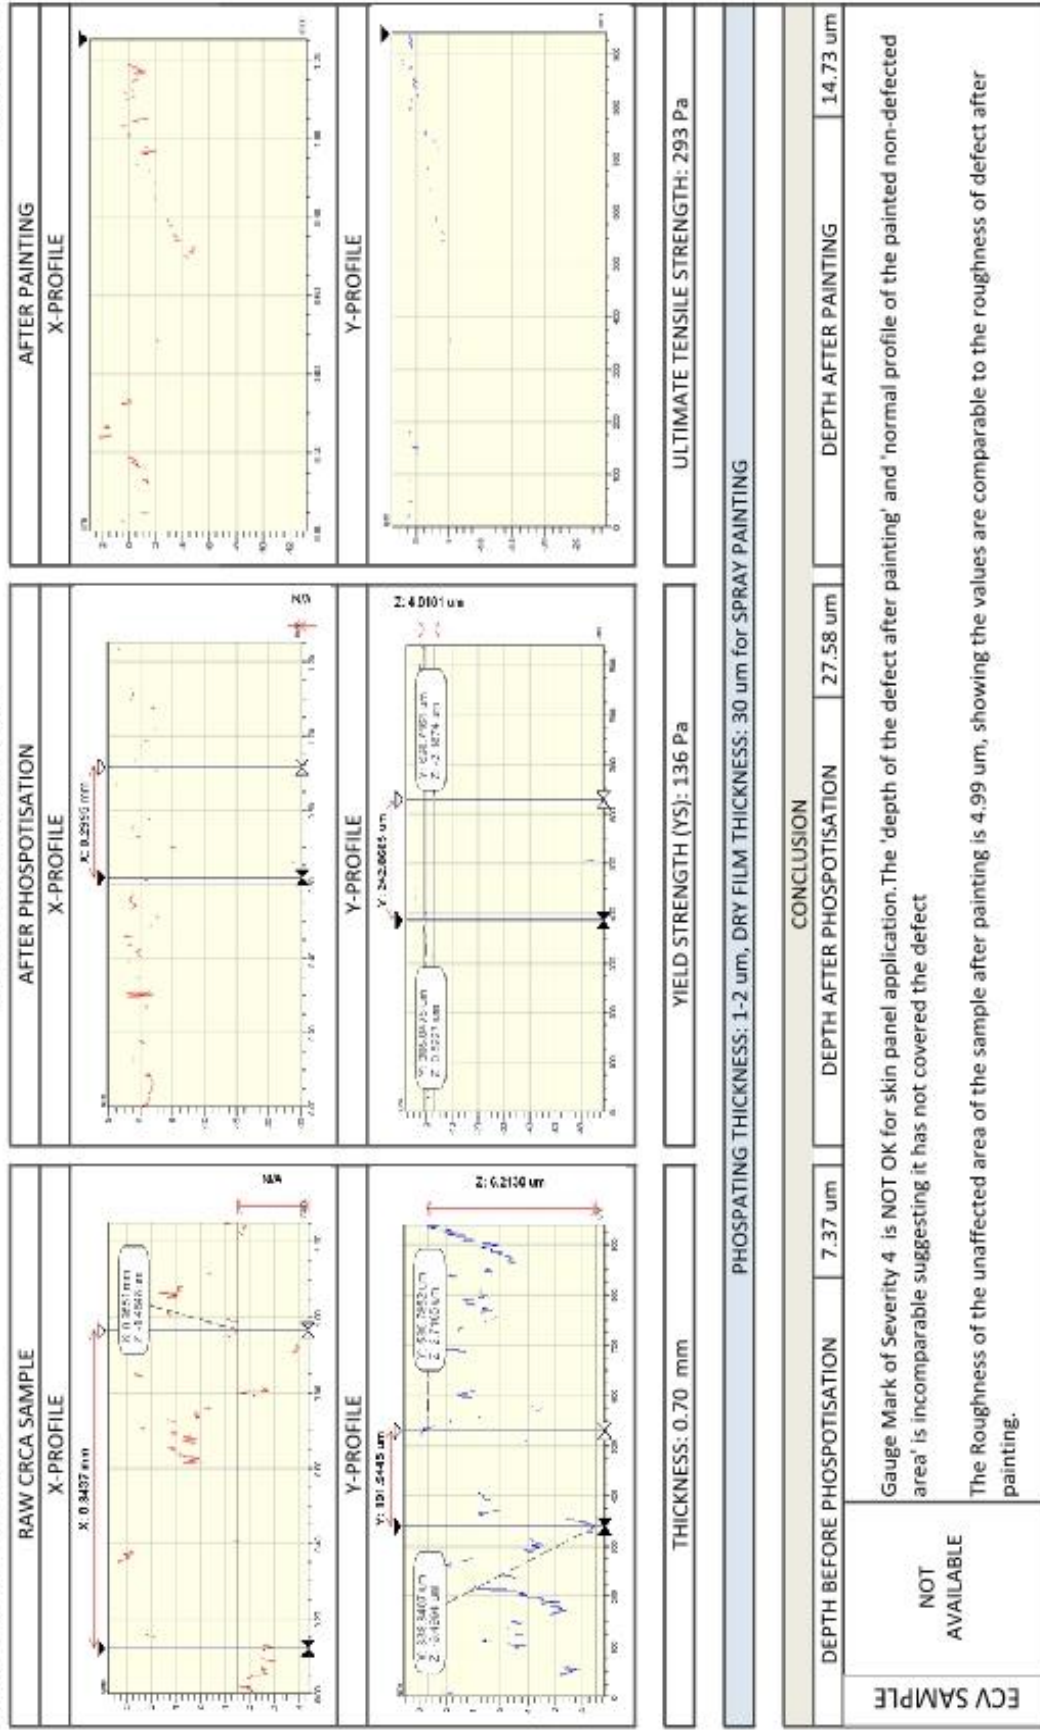
Fig: 5.5.2

SEVERITY: 4

DEFECT: GAUGE MARK

COIL ID: 2544511000
